An Analysis of Possible Microbiologically Influenced Crevice Corrosion of 316 Stainless Steel in a Seawater Environment

MASTER OF SCIENCE IN OCEANOGRAPHIC ENGINEERING
at the
MASSACHUSETTS INSTITUTE OF TECHNOLOGY
and the
WOODS HOLE OCEANOGRAPHIC INSTITUTION

SEPTEMBER 1996

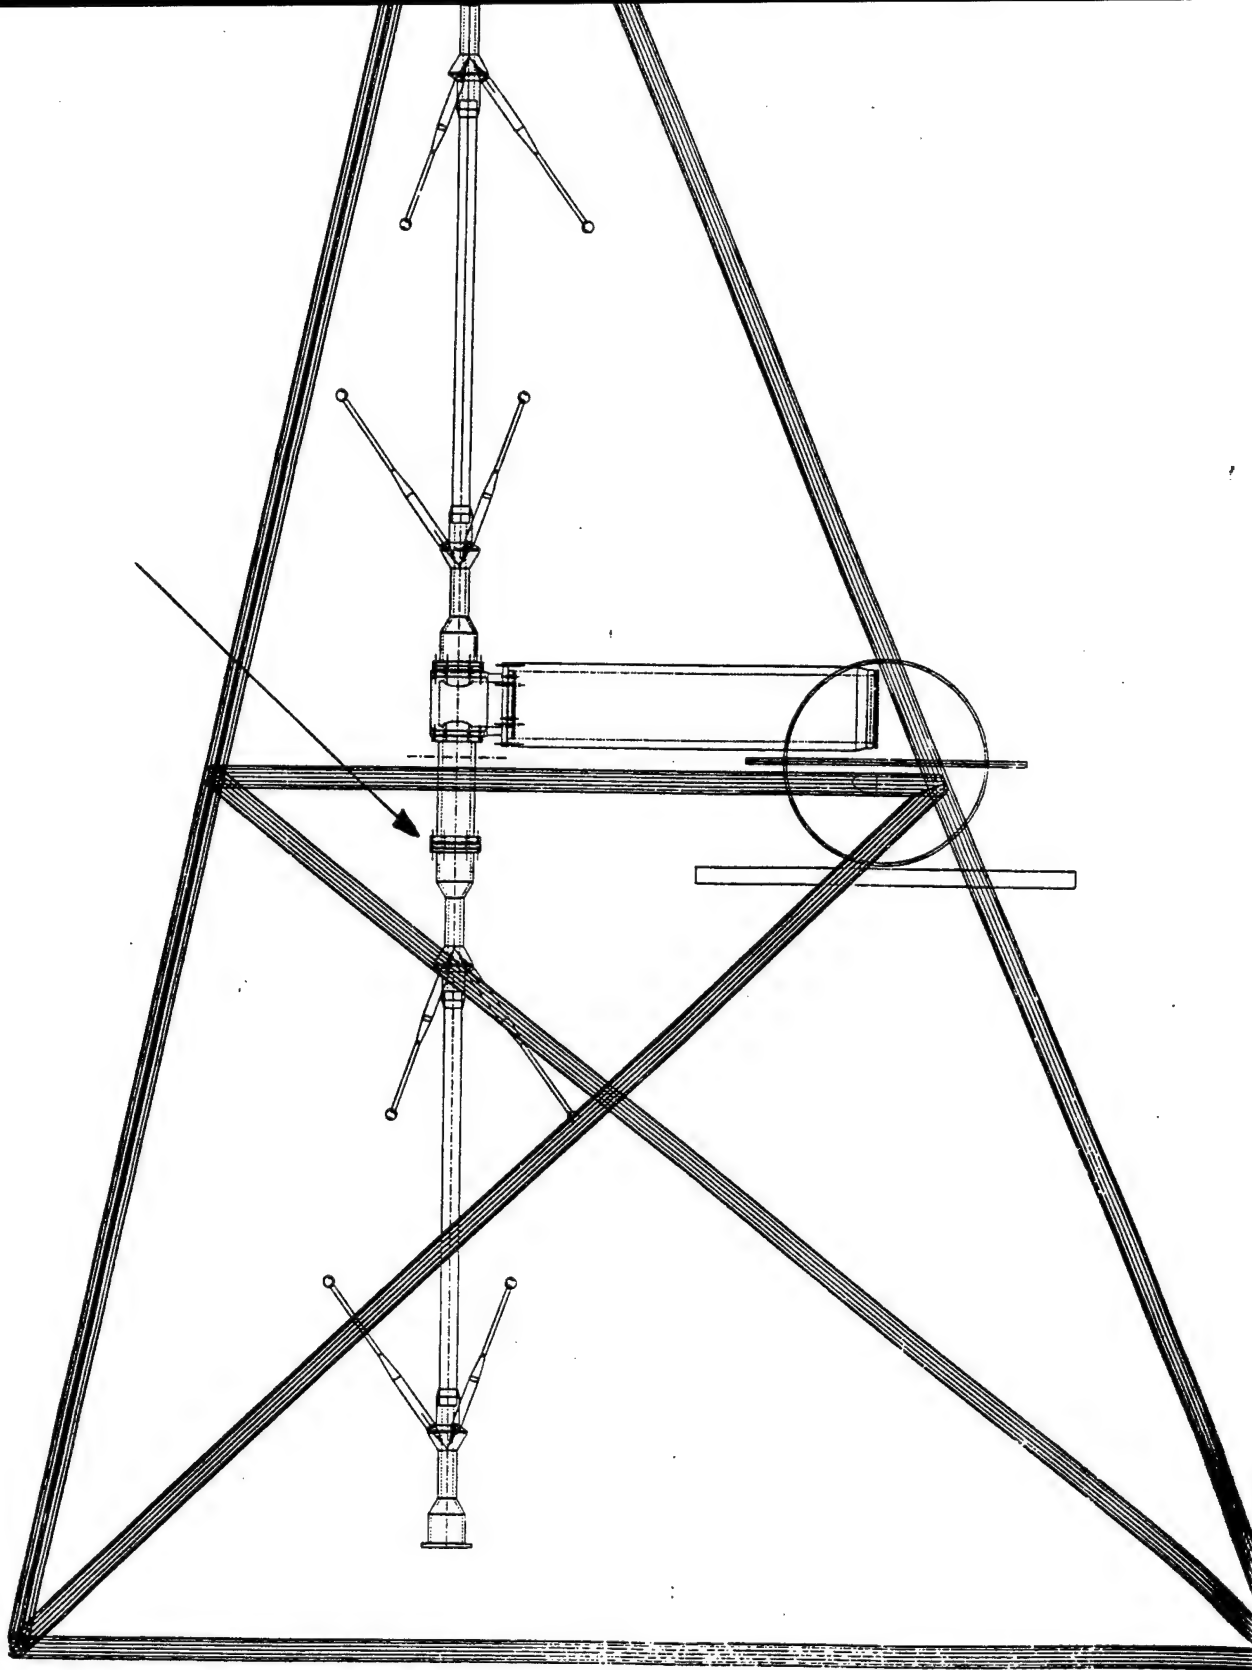
Figure 1-3: Line Drawing of Vorticity Instrument within Support Pyramid

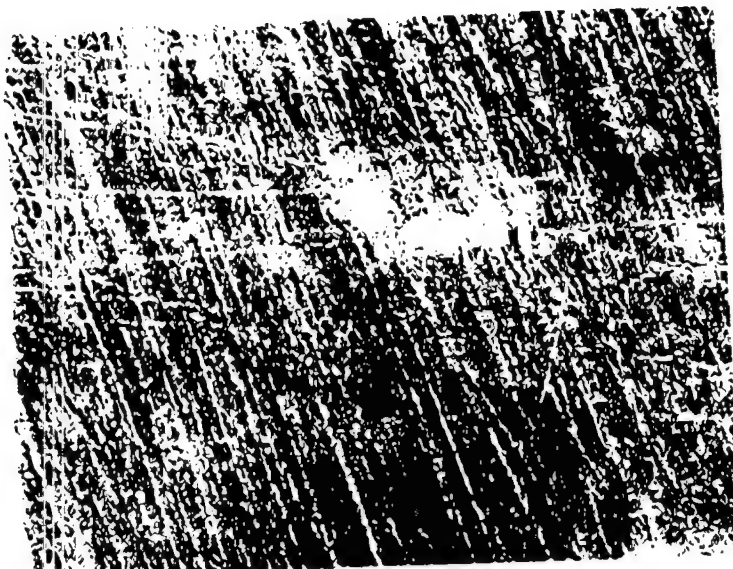
Figure 5-5: Active Seawater Specimen (100X magnification)

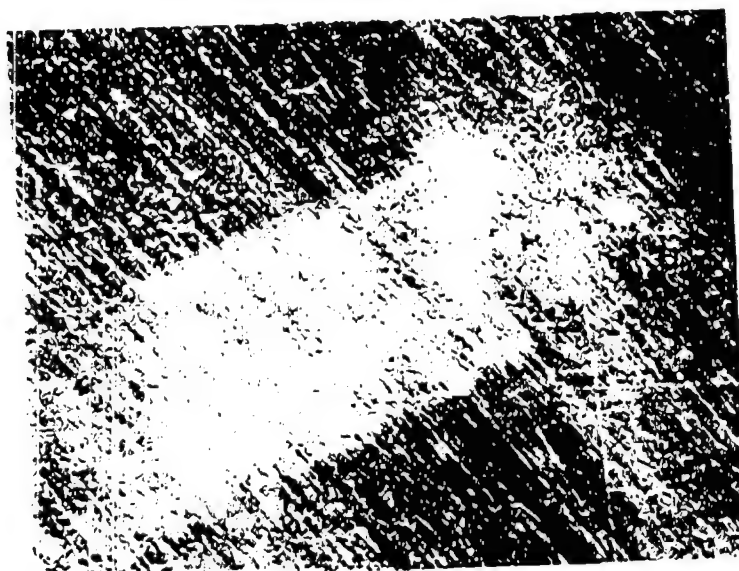
Figure 5-6: Active Seawater Specimen (100X magnification)

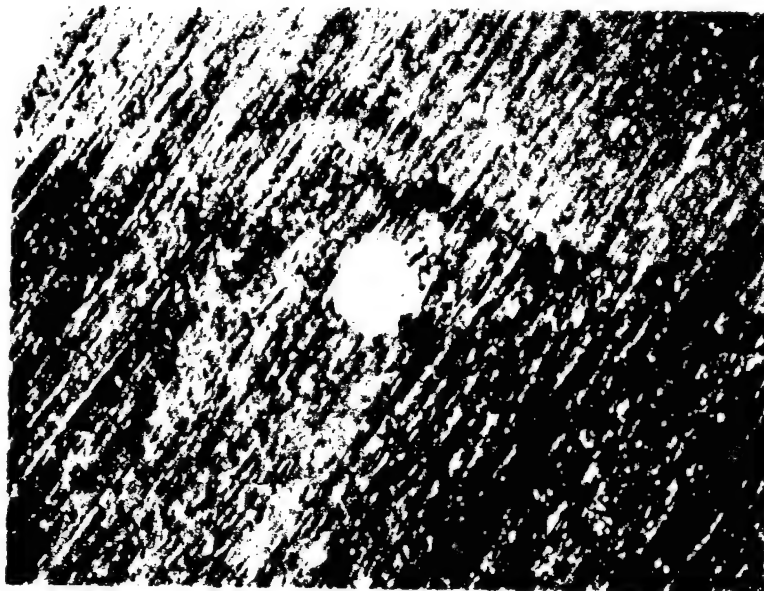
Figure 5-8: Active Seawater Pit (100X magnification)
